RE: DEP File No. 034-1329 – Salt Marsh Monitoring Report  
5 Bare Cove Lane, Hingham, Massachusetts

**PHOTOGRAPHIC  
DOCUMENTATION**  
Salt Marsh Restoration  
5 Bare Cove Lane  
Hingham, Massachusetts

SITEC PROJ. NO.  
SE18-1374

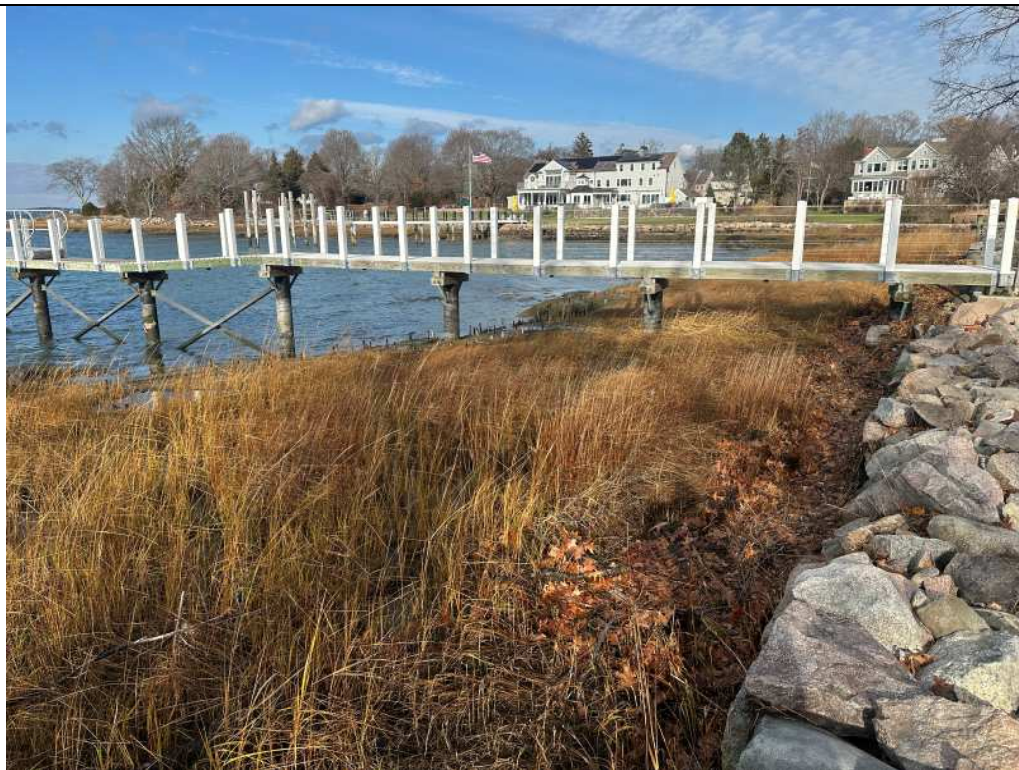
C-1

- *Spartina alterniflora* – South Side of Dock: The majority of plantings on the south side of the dock are in good condition with observed new growth, with the exception of the plantings that were clearly planted too low in the intertidal zone.

Main area of salt marsh restoration area on south side of dock. Plantings are thriving.

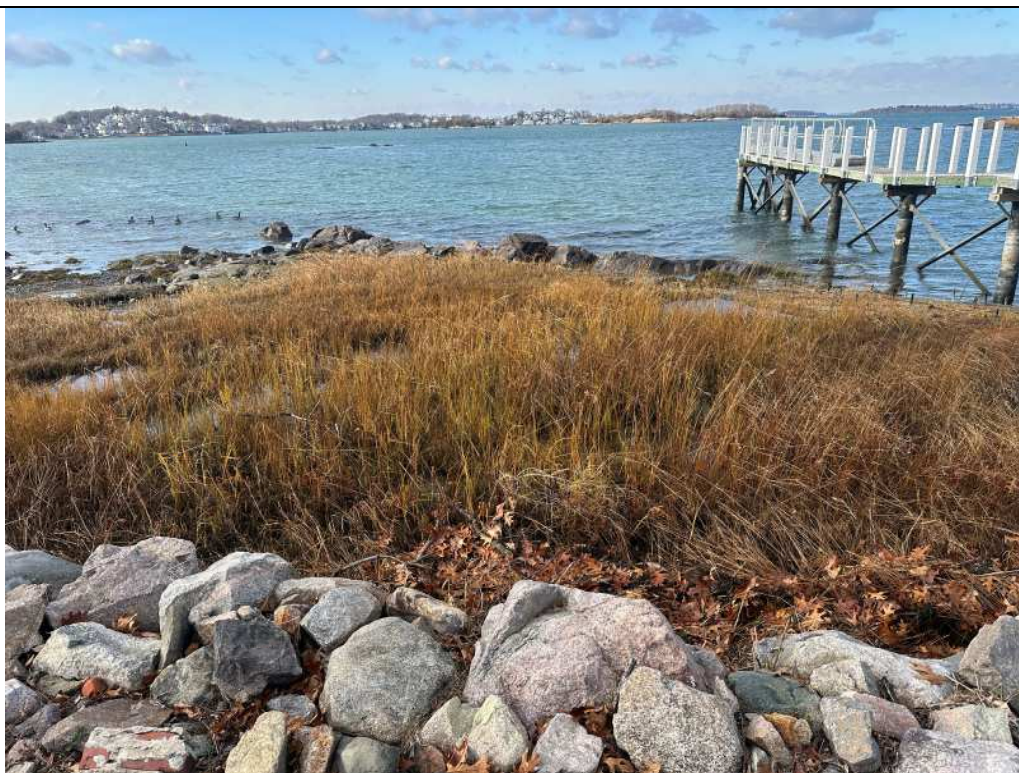
C-2

Main area of salt marsh restoration area on south side of dock. Plantings are thriving.

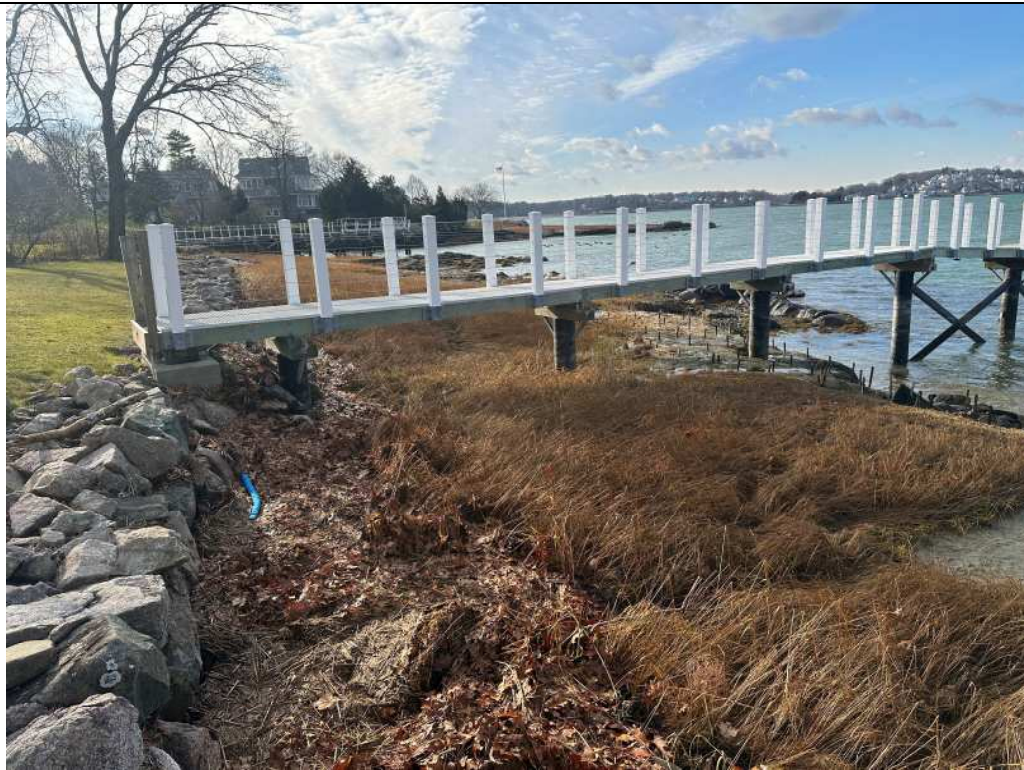
C-3

Thriving salt marsh vegetation beneath dock.

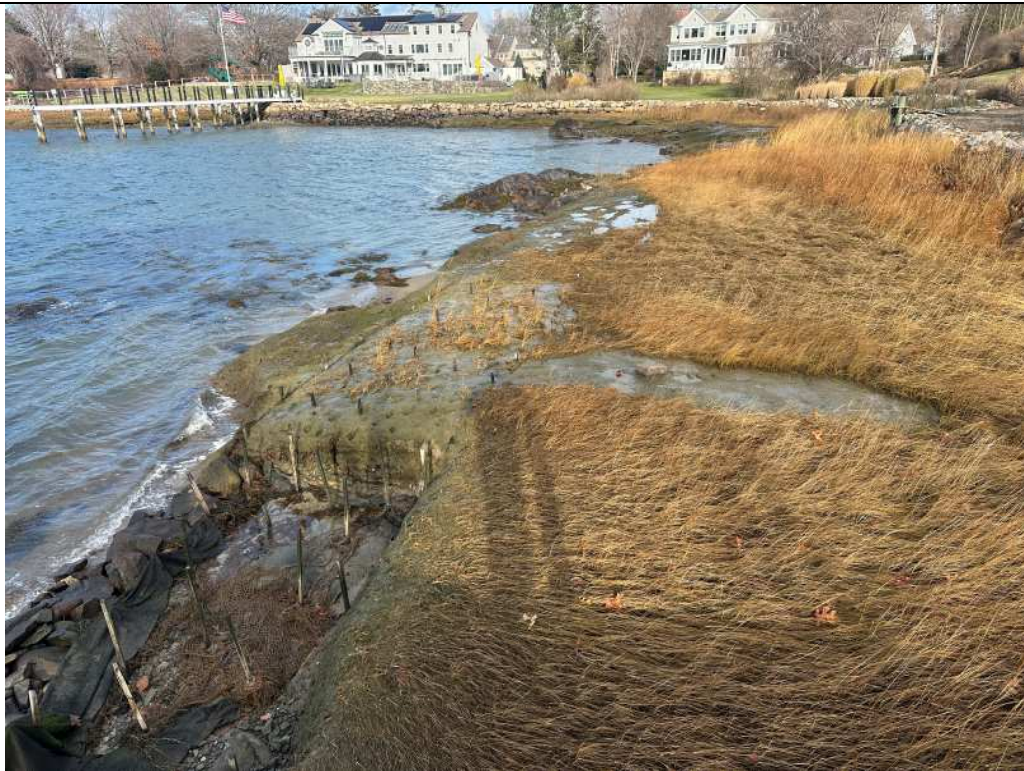
C-4

- Float-Damaged Area: The previously restored float-damaged area has experienced settlement and washout. The installed rock sill remains intact and stable. SITEC recommends that the filter fabric and grade stakes be removed from the area.

Float damaged area has washed out. Filter fabric and stakes should be removed.

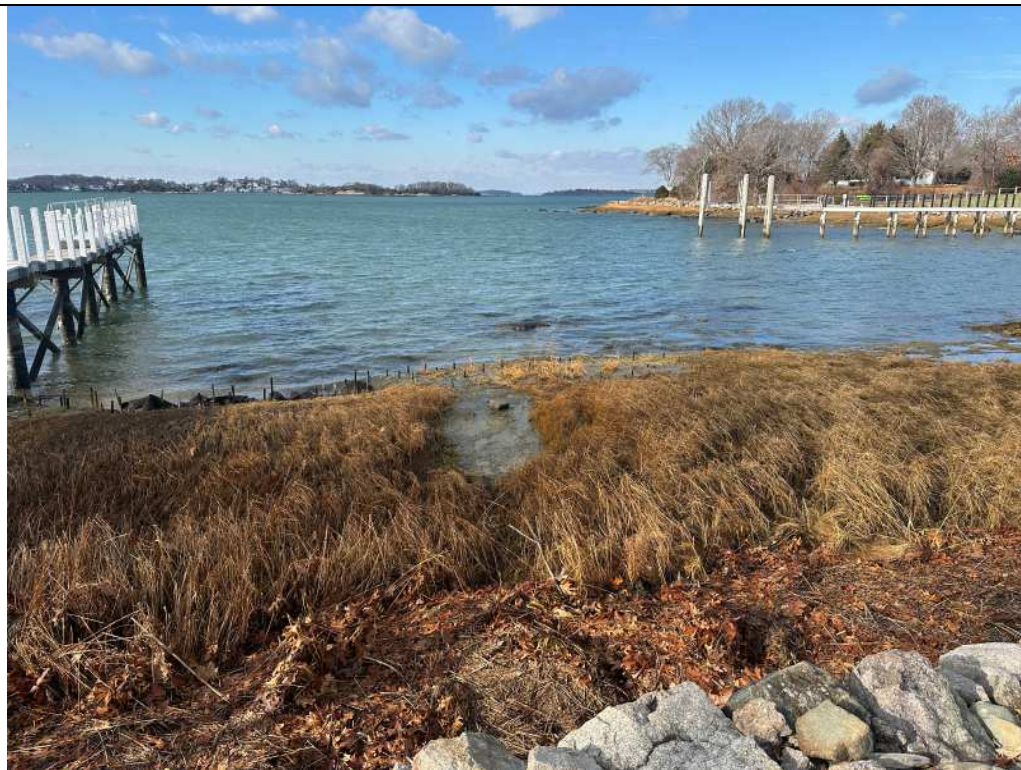
- Coir Matting: The unsecured coir matting referenced in the previous report was removed from the salt marsh vegetation. The coir matting damaged a 10'x3' area on the northerly side of the dock. SITEC recommends that replacement *Spartina alterniflora* plantings be planted in this location in the spring of 2026 (see photos).

Northerly side of dock. 10'x3' area with no vegetation due to coir matting damage (requires replacement planting)
