# CAPITAL NEEDS ASSESSMENT REPORT

██████████ High School  
██████████  
██████████ MA ██████████

Re: ██████████ High School, ██████████ MA  
Capital Needs Assessment  
Rimkus Consulting Group, Inc. Project # ██████████

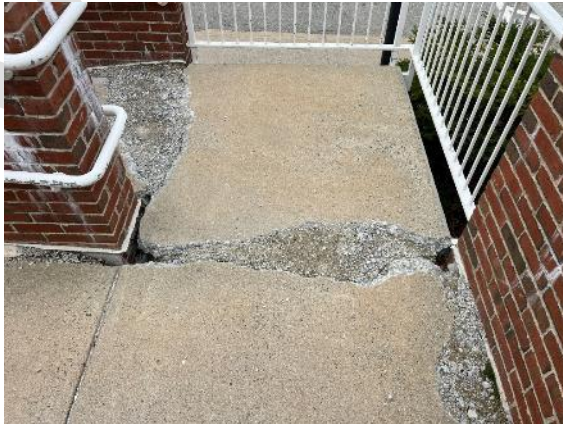
Accessible ramp at entry of building that is currently closed due to concrete degradation.

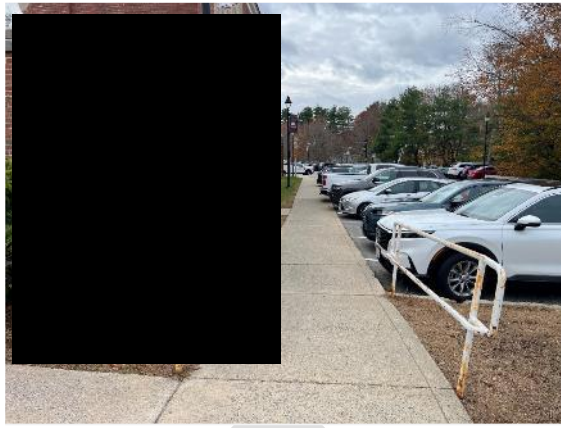
Degradation observed at main entryway concrete ramp.

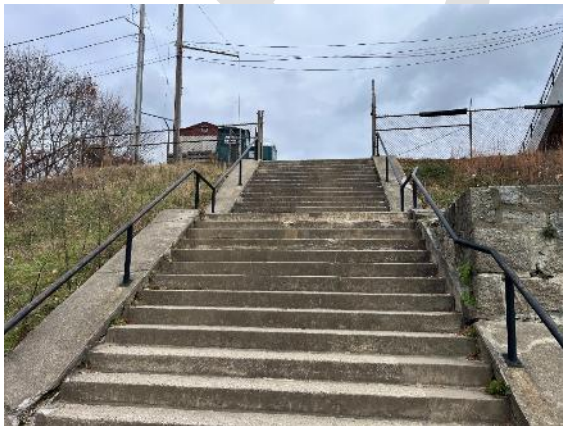
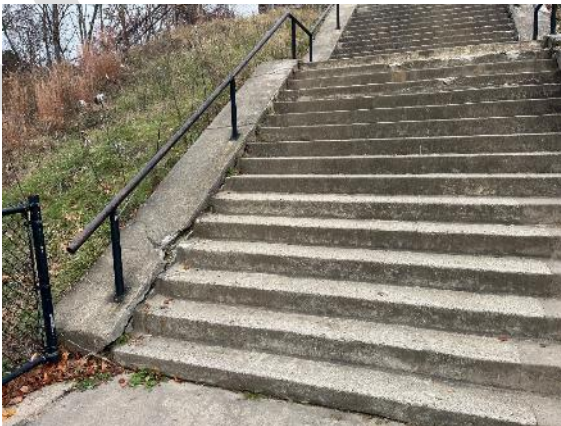
Damage to concrete sidewalk and curbing from snow removal and freeze/thaw cycling.

- Scrape and paint exterior handrails around perimeter of building, including patios and entryways in Year 3 and Year 8.
- Perform annual concrete repairs at sidewalks and curbing throughout property for damage caused during snow removal and freeze/thaw cycles (R&M).

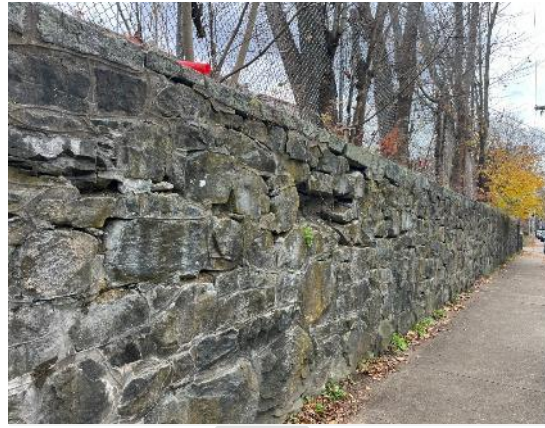
Degraded fieldstone wall between football and baseball fields.

- Repair and repoint loose fieldstone at failing perimeter retaining wall, including between football and baseball field in Year 1.
- Repair leaning retaining wall at west parking lot, circa 2002 in Year 1.

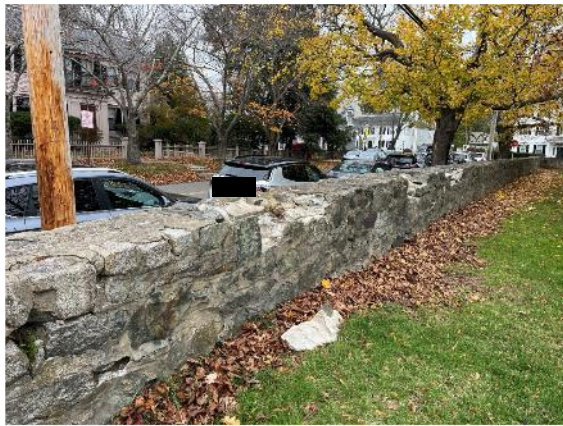
Degraded fieldstone wall along [REDACTED]

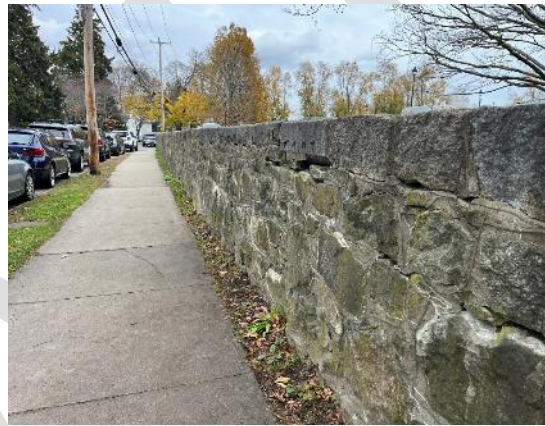
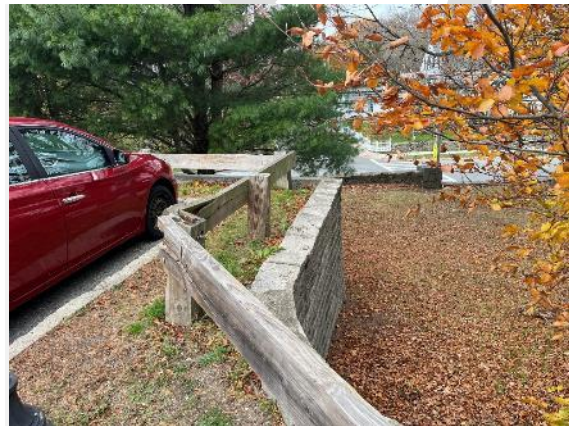
Degraded fieldstone wall along [REDACTED]

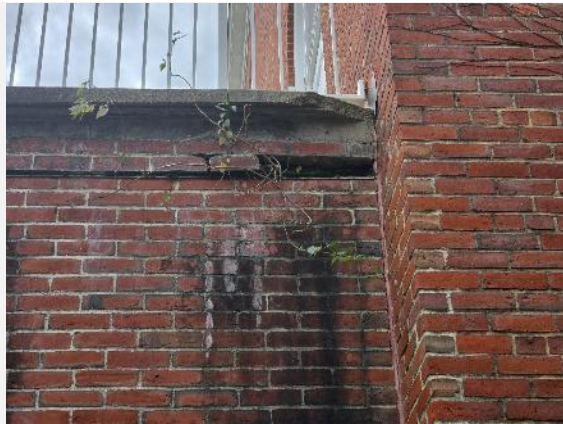
Damaged and missing soffit.

- cafeteria at courtyard.
- Repair and replace damaged and missing exterior soffits.

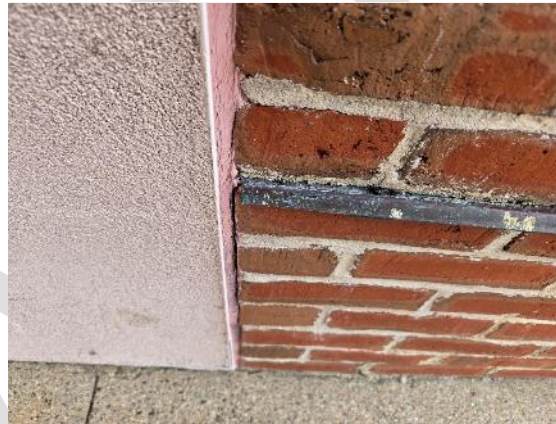
Displaced and damaged brick masonry where ivy was removed.

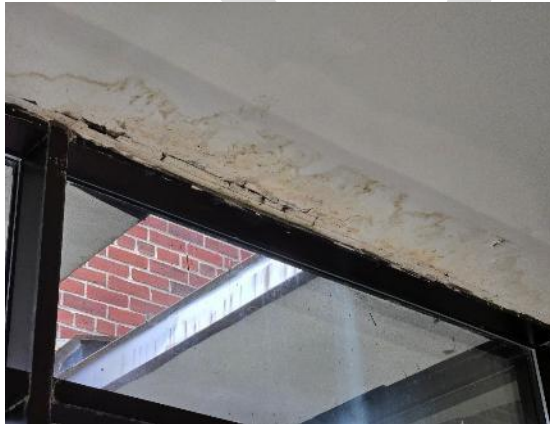
Crazing and failed sealant.

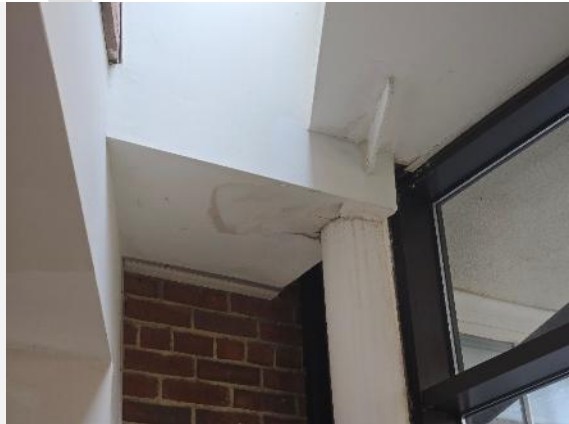
Stained ceiling below skylight and metal roof at courtyard.

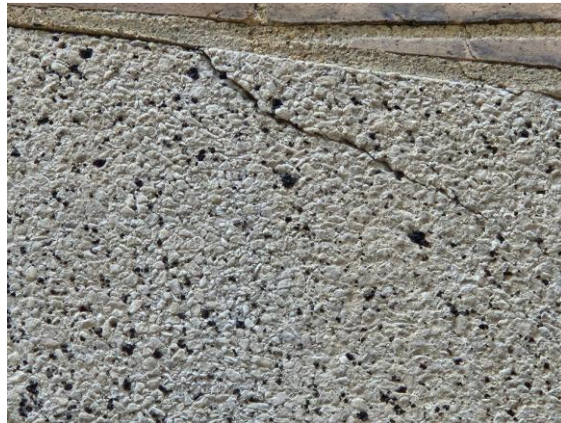
Cracked stone.

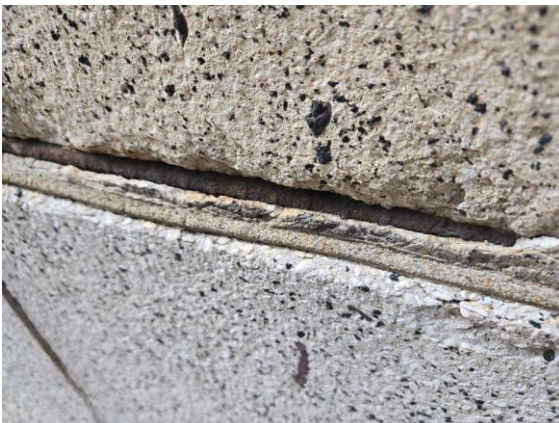
Spalled stone with exposed rebar.

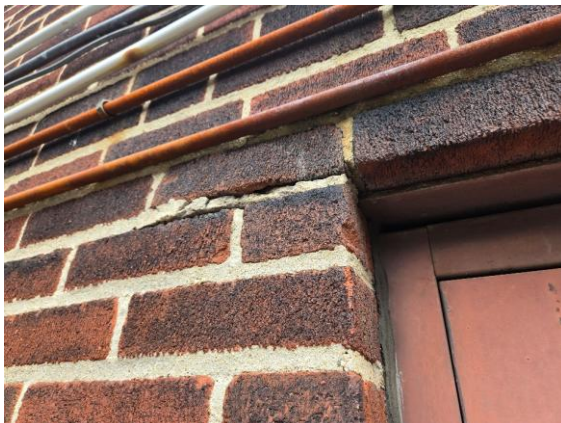
Failed mortar and rust jacking at lintels.

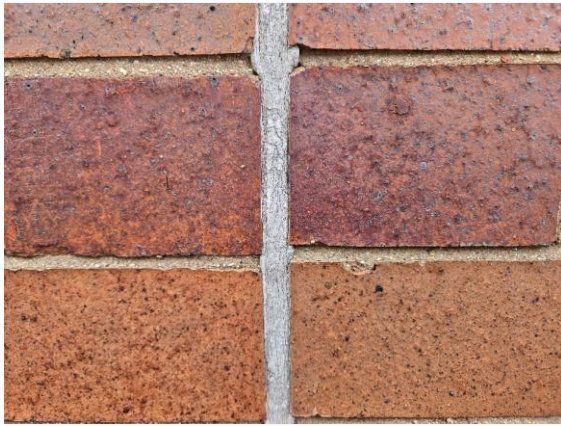
Crazing sealants.

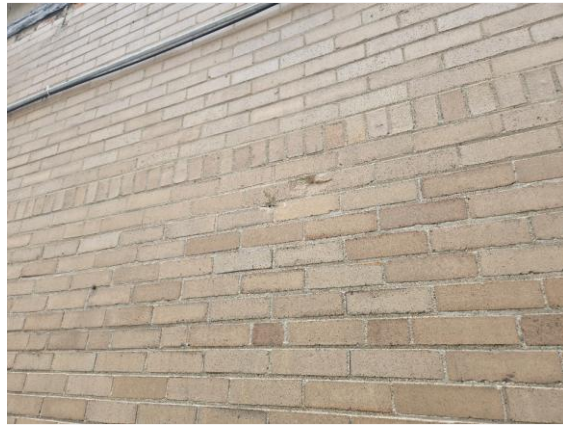
Spalled brick.

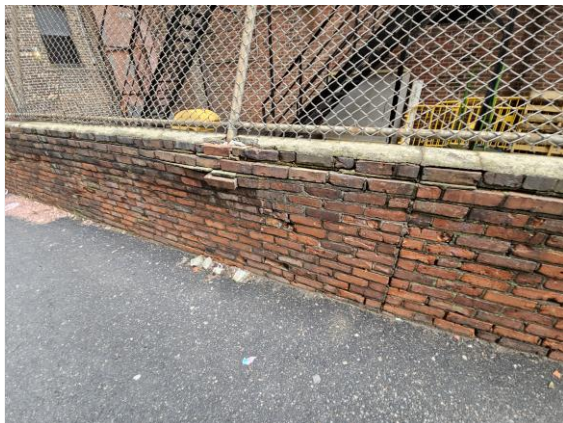
Alternate view of failed retaining wall.

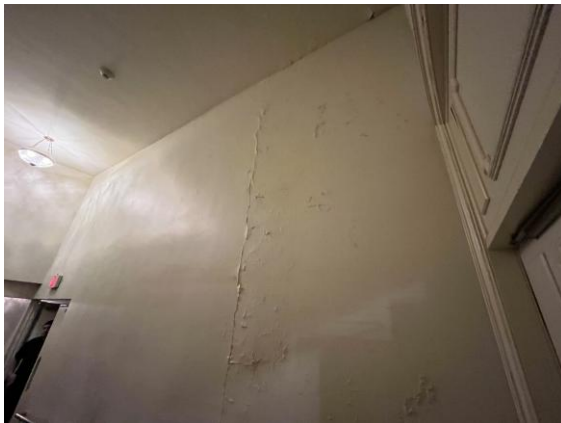
Typical water damaged observed along the North side of the building.

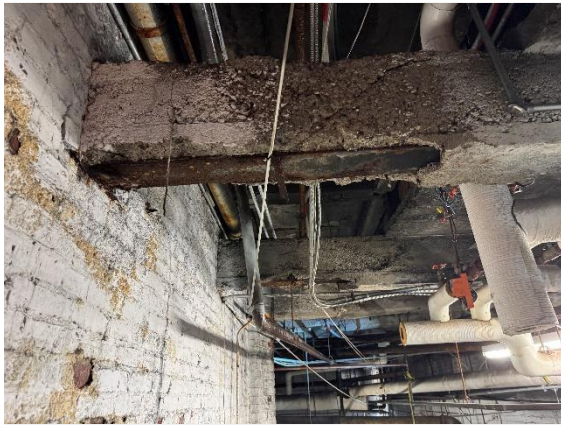
Typical beam deterioration in basement.

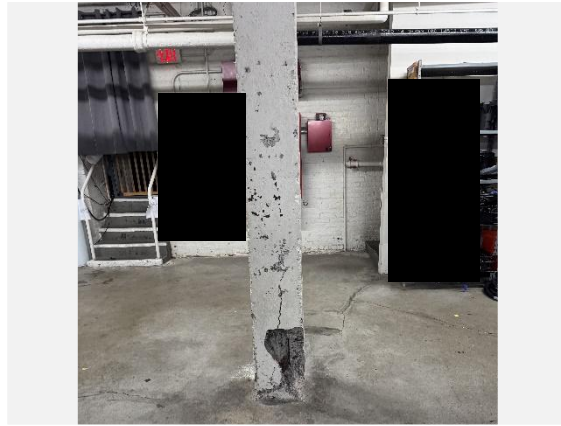
Typical rust jacking condition in basement columns.

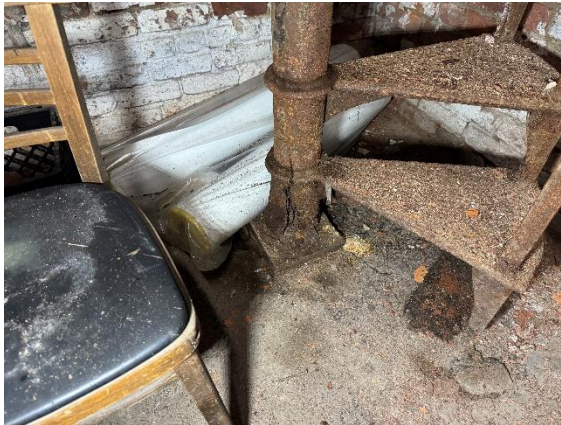
Deteriorated spiral staircase base.

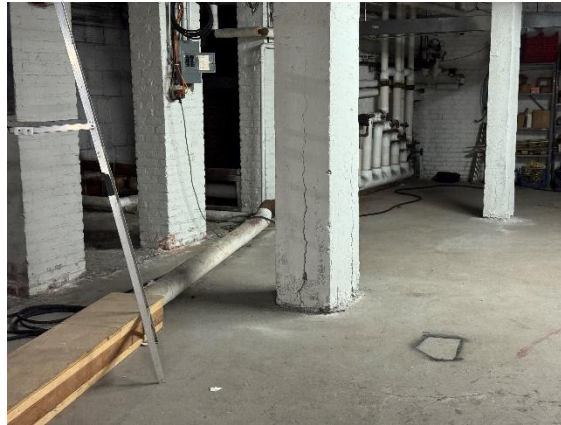
Typical rust jacking condition in basement columns.

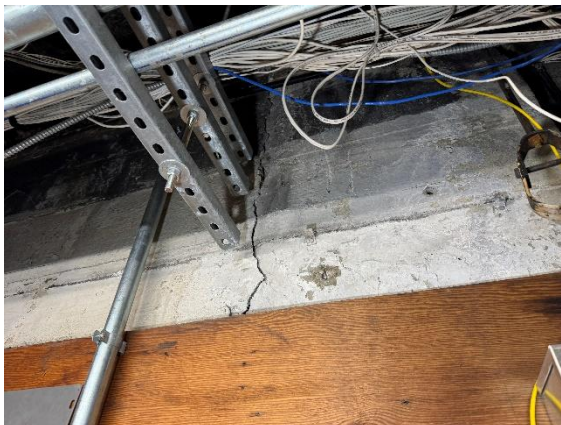
Settlement cracking in exterior foundation wall.

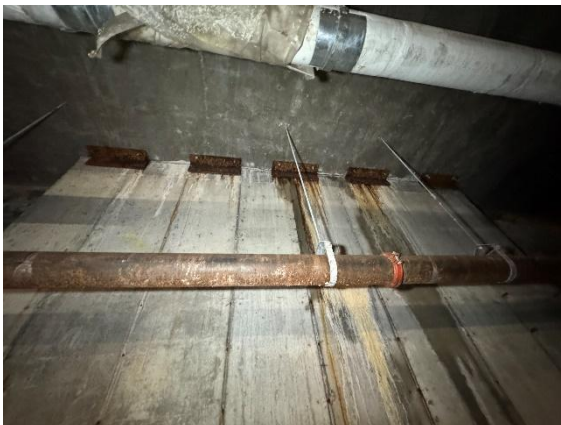
Water intrusion in sidewalk vault.

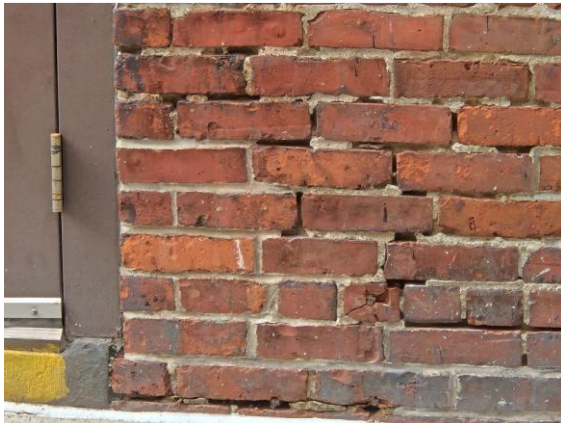
Deteriorated mortar.

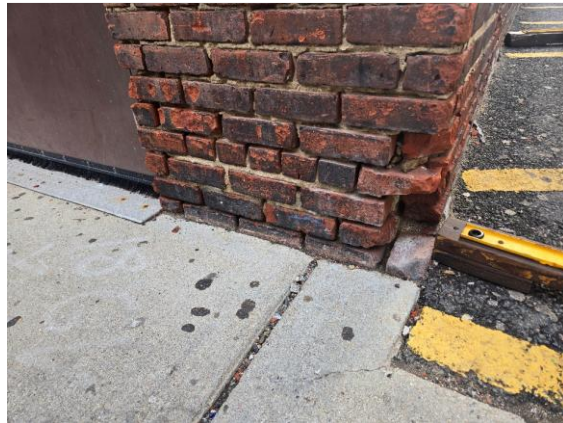
Missing/loose bricks.

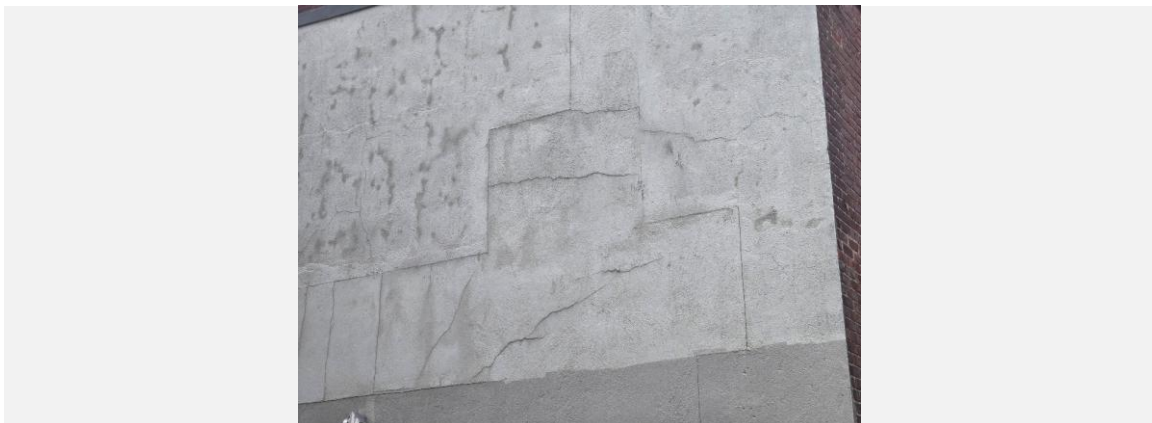
Cracked concrete parge coating.
