RE: DEP File No. 034-1329 – Salt Marsh Monitoring Report  
5 Bare Cove Lane, Hingham, Massachusetts

**PHOTOGRAPHIC  
DOCUMENTATION**  
Salt Marsh Restoration  
5 Bare Cove Lane  
Hingham, Massachusetts

SITEC PROJ. NO.  
SE18-1374

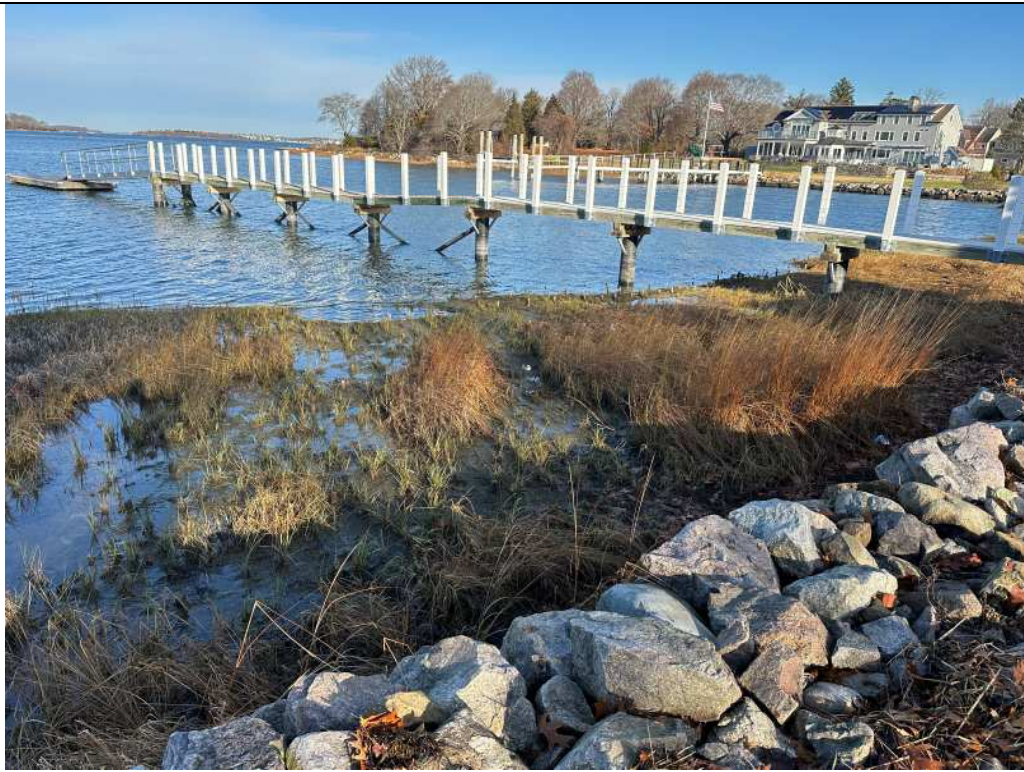
C-1

Main area of salt marsh restoration area on south side of dock. Plantings are thriving.

- The overwhelming majority of new *Spartina alterniflora* plantings in the main restoration area on southerly side of the dock are in good condition and have shown significant new growth.

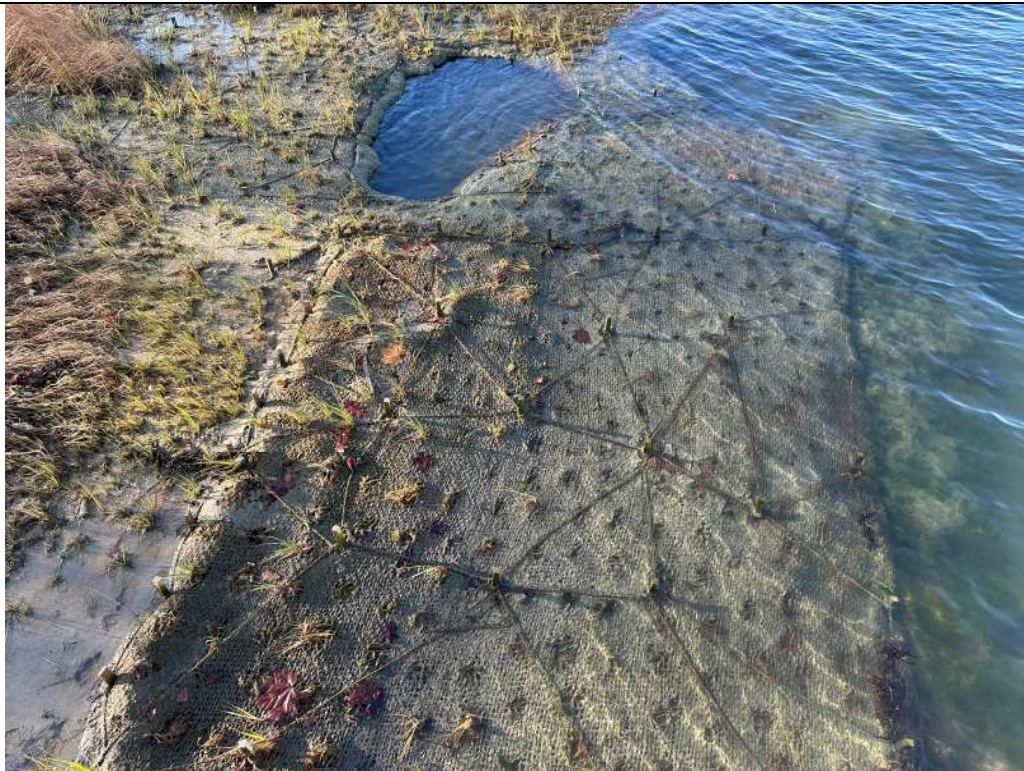
C-2

Seaward edge of southern side of salt marsh restoration area. Plantings toward seaward edge too low to thrive.

- Some of the new *Spartina alterniflora* plantings on the northerly side of the dock are also in good condition and have shown new growth.
- It is clear that many of the plantings on the southerly and northerly sides of the dock along the seaward edge of the restoration area were planted at elevations that are too low for the plantings to survive. These plantings are in too much water during the tide cycle and have died off. SITEC estimates that these areas of die-off are well under 25% of the overall restoration area.

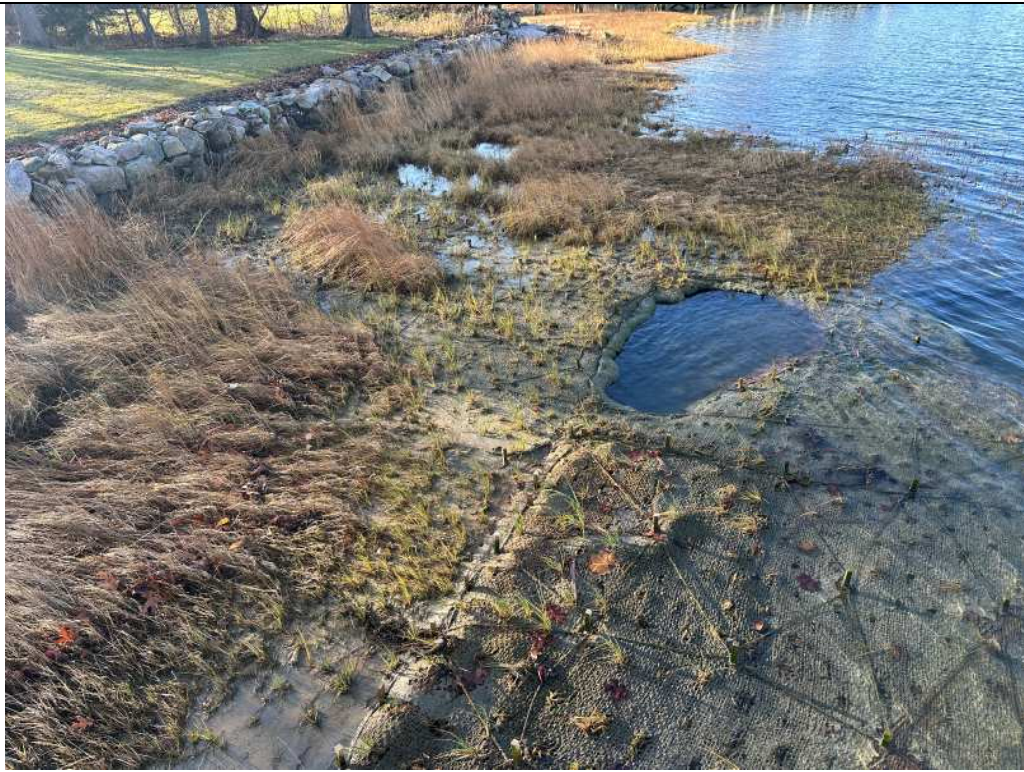
C-3

Salt marsh restoration area on southerly side of dock.

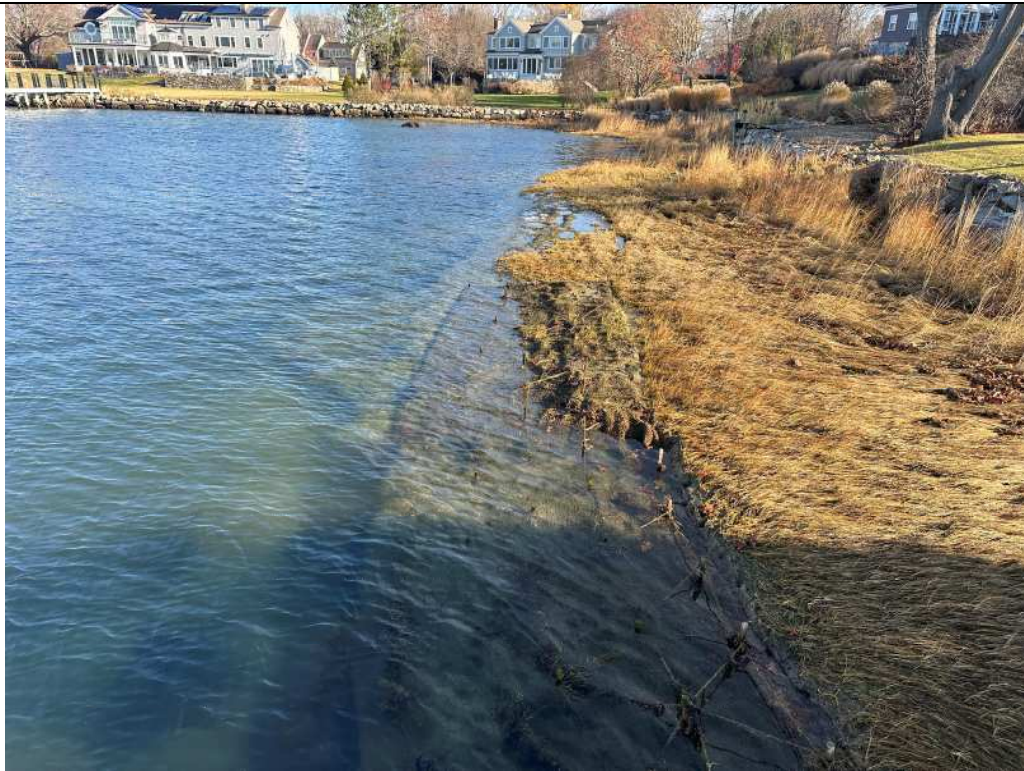
C-4

Salt marsh restoration area on northerly side of dock. Most plantings in this area are too low to thrive.

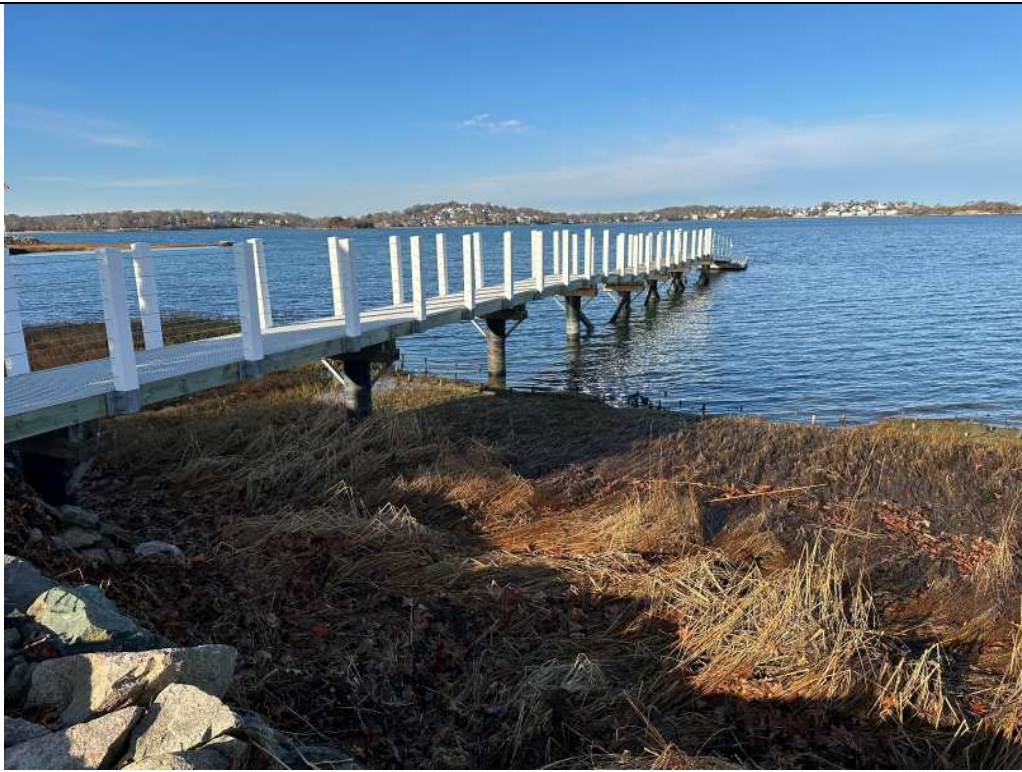
C-5

Salt marsh restoration areas to the north of dock and beneath dock.

- The condition of the new plantings under the landward end of the dock was difficult to determine because the area was covered with leaves. New growth was not observed. It is possible that this area may require additional salt marsh plantings that are more tolerant to dryer conditions as this area is in the higher reach of the intertidal zone. It is recommended that this area be raked out by hand to promote growth in the early spring.

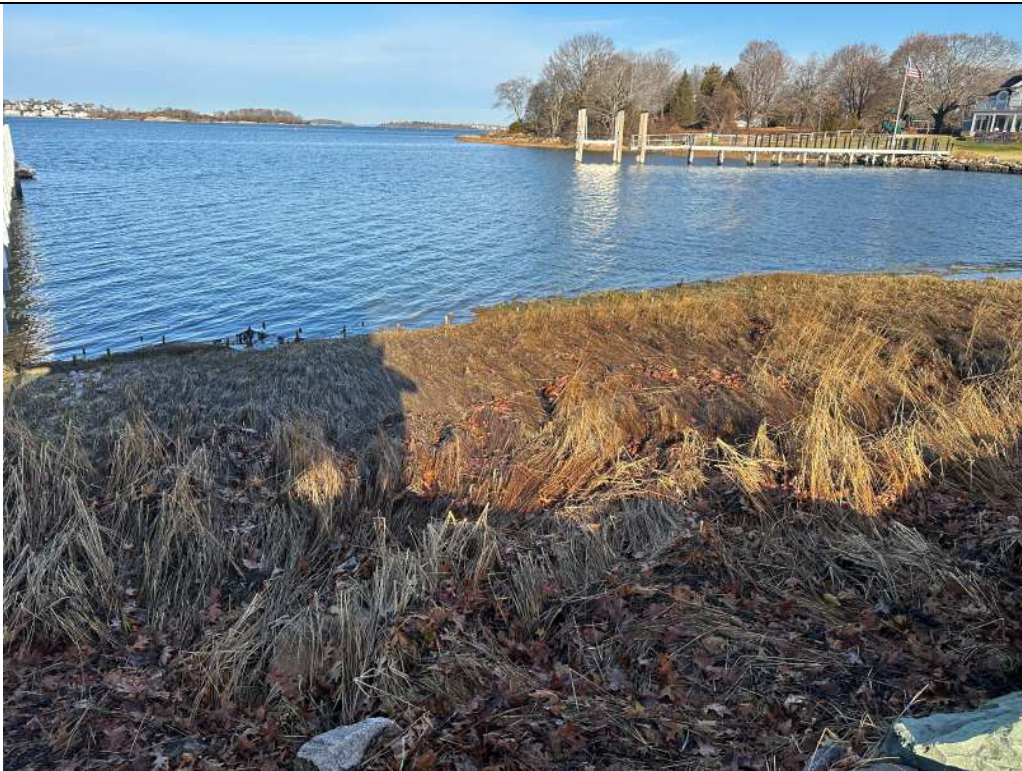
C-6

Salt marsh restoration area to the north of dock.
