# CAPITAL NEEDS ASSESSMENT REPORT

██████████ High School  
██████████  
██████████ MA ██████████

Re: ██████████ High School, ██████████ MA  
Capital Needs Assessment  
Rimkus Consulting Group, Inc. Project # ██████████

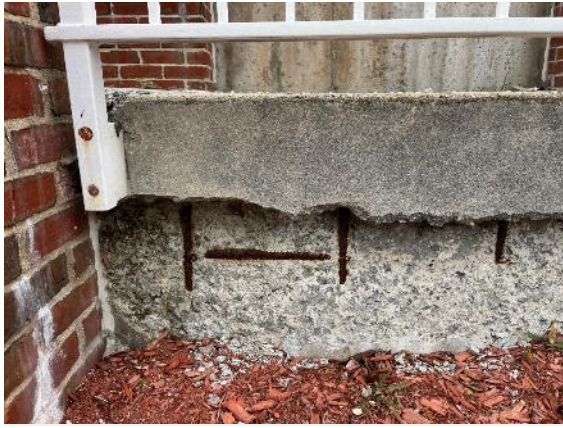
Degradation observed at main entryway concrete ramp.

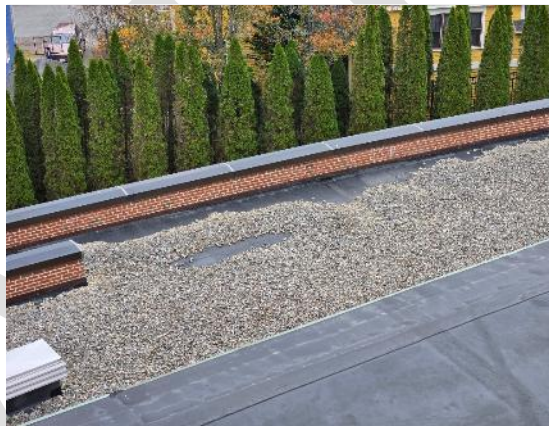
Ballasted EPDM membrane roofing.

- Replace EPDM roof. Assumes retaining most insulation and installing a "go over" new single ply membrane system. Cost includes removal of aggregate ballast at lower roof area.
- Perform regular inspections and maintenance of roof including drain cleaning.

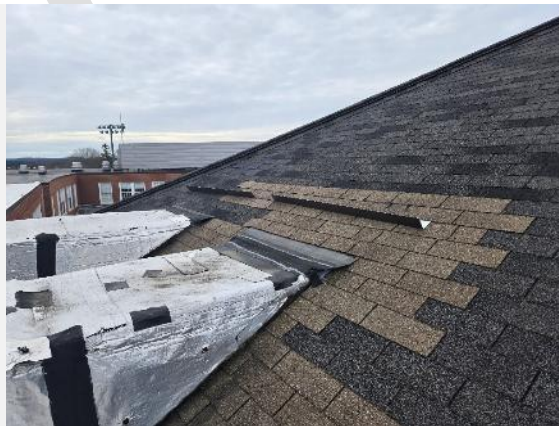
Patched asphalt shingles.

- Replace asphalt shingles.

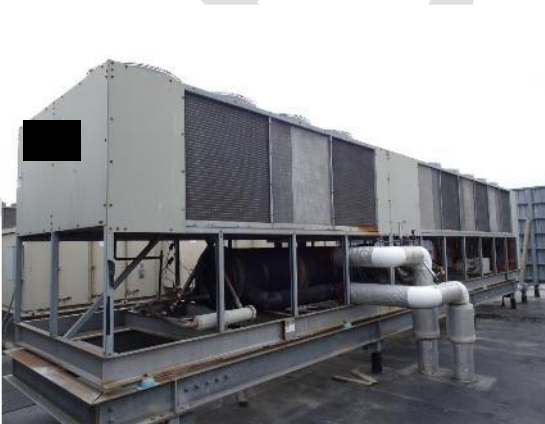
One of two roof mounted air cooled chillers.

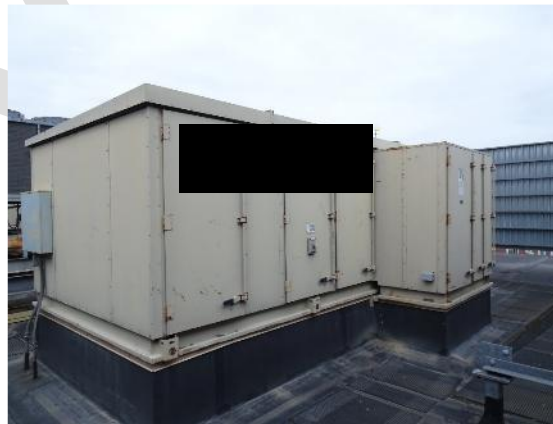
One of three roof mounted AHUs.

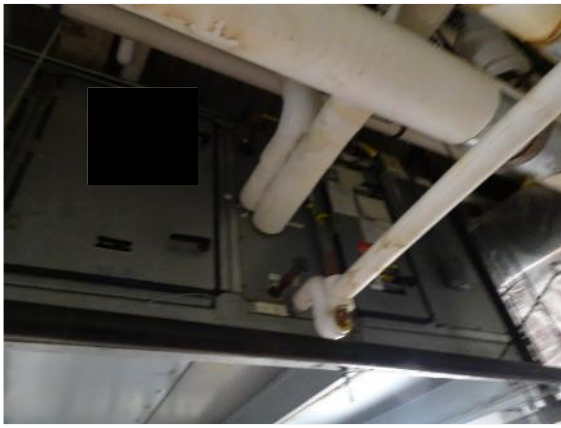
One of nine AHUs inside the building.

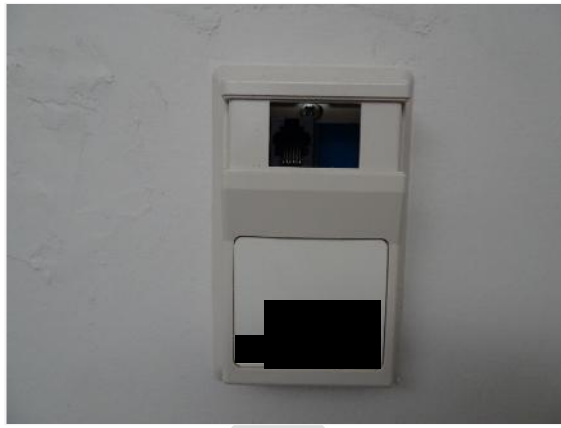
Typical BMS system sensor.

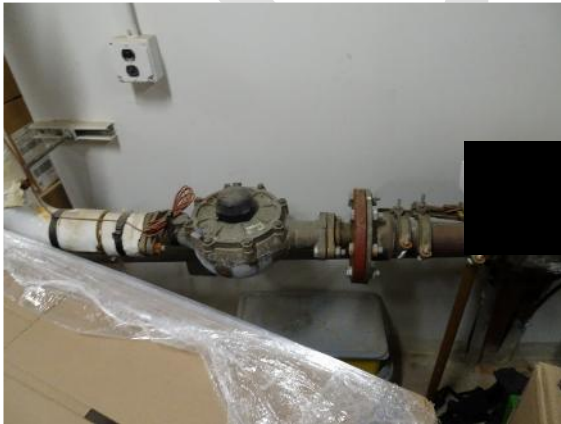
Domestic water main and meter.

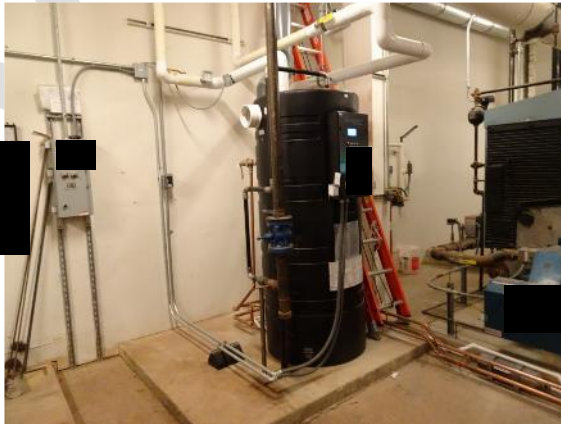
Main domestic water heater.

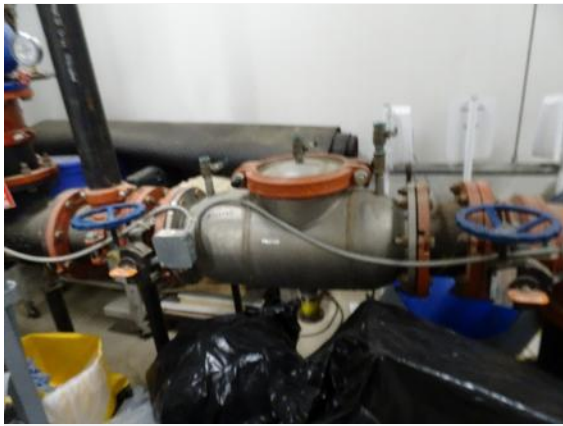
Fire protection main and backflow device.

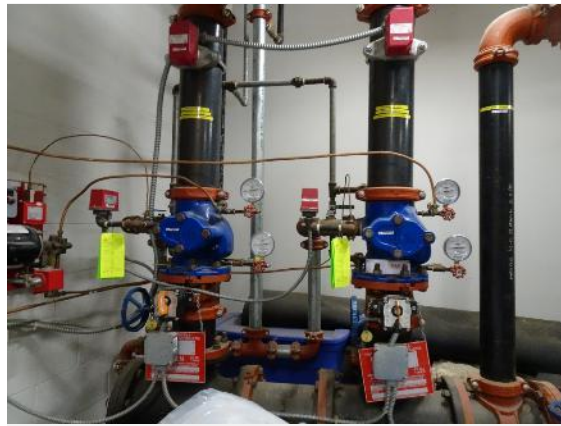
Sprinkler system risers.

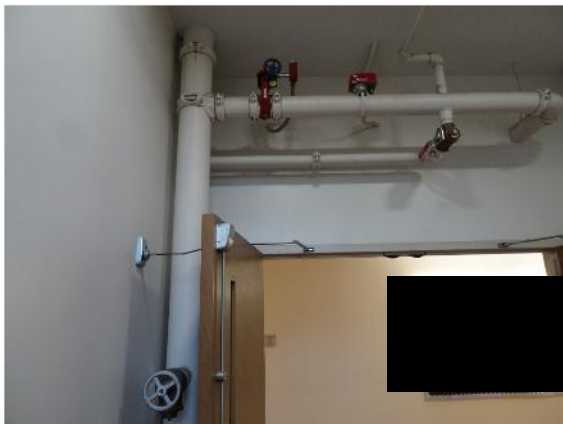
Typical stairway wet riser and sprinkler system control.

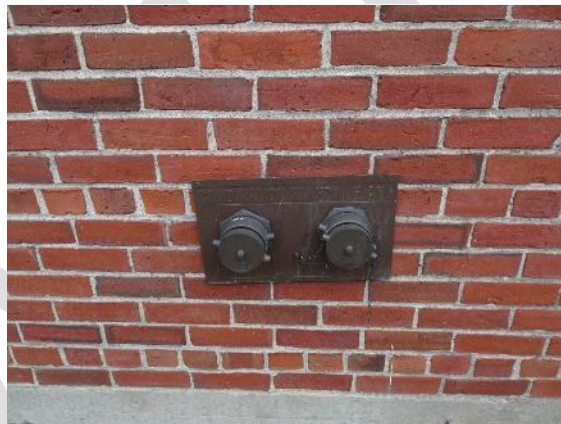
Exterior connection for fire department use.

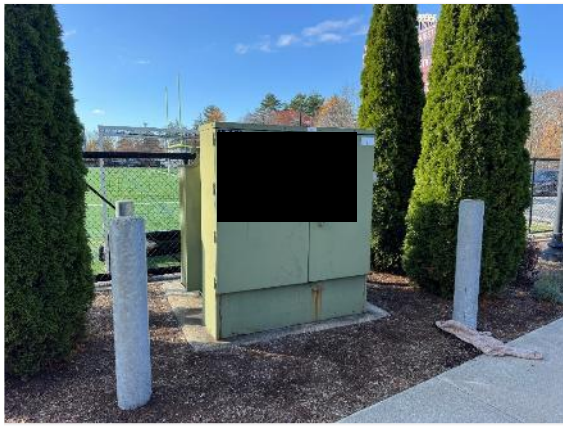
Electrical utility transformer.

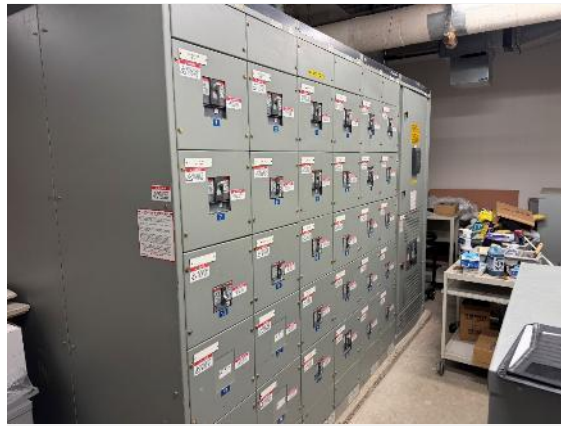
Electrical main switchboard.

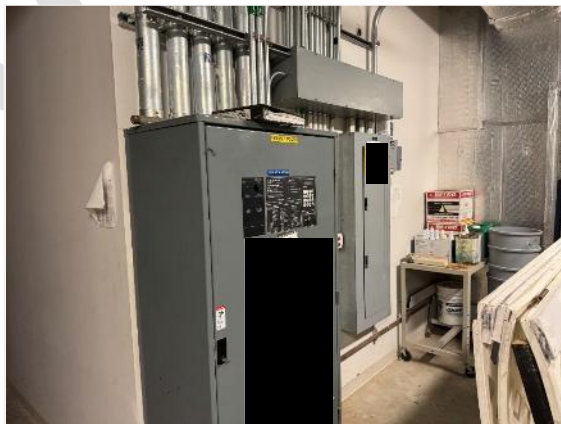
Automatic transfer switch.

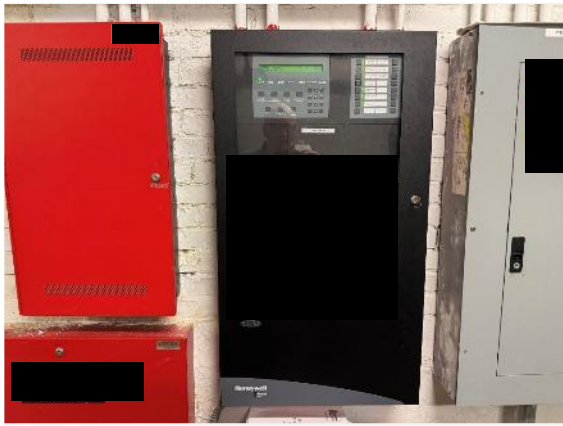
Fire alarm control panel.

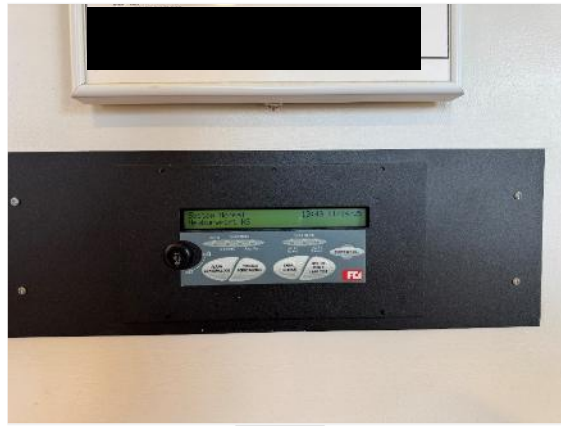
Fire alarm remote annunciator.

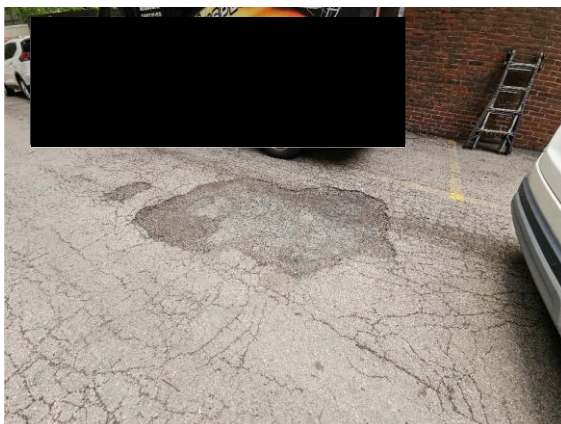
Asphalt driveway at loading dock.

| Item | Qty. | Unit | Unit Cost | Line Total-<br>Uninflated Capital | Line Total-<br>Inflated Capital | Immediate<br>Repairs | Year 1<br>2026 | Year 2<br>2027 | Year 3<br>2028 | Year 4<br>2029 | Year 5<br>2030 | Year 6<br>2031 | Year 7<br>2032 | Year 8<br>2033 | Year 9<br>2034 | Year 10<br>2035 |
|---|---|---|---|---|---|---|---|---|---|---|---|---|---|---|---|---|
| Implement asphalt crack repair and sealing program at existing asphalt. Assume 55,000 SF @ \$.35/SF every 5 years beginning in Year 1 (R&M). | 55,000 | SF | \$ 0.35 | \$ 38,500 | | | \$ 19,250 | | | | \$ 19,250 | | | | | |

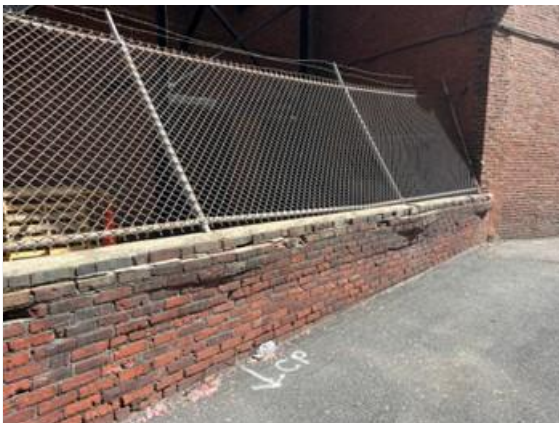
Bowing retaining wall and fencing along [REDACTED]

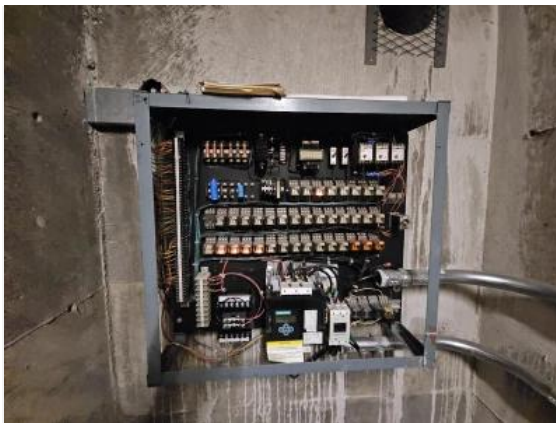
Freight Elevator Relay logic controller

- Replace Vertical Incline Lift in the next 2-5 years
- Modernize the freight elevator in the next 5-7 years.

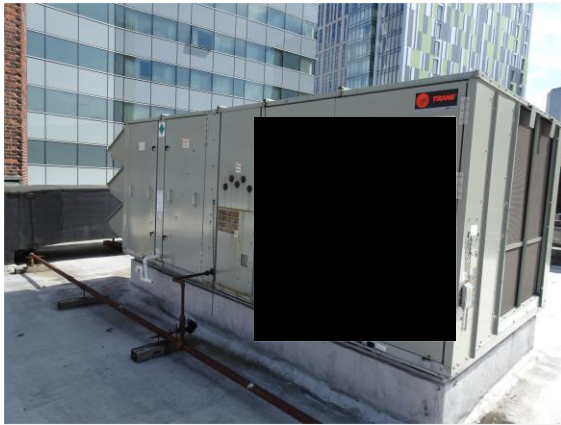
Typical HVAC rooftop unit.

- [REDACTED]
- Replace the two 15-ton RTU package units serving the stage area in year 1.
  - Replace the two split system HVAC units serving the 2<sup>nd</sup> floor office and the ticket office totaling 5 tons in year 1.
  - Replace the two split system HVAC units serving lobby/rear orchestra areas totaling 30 tons in year 1.
  - Replace the split system HVAC unit serving the dressing rooms totaling 7.5 tons in year 1.
  - Budget amount to account for annual replacement/repair of domestic, sanitary, steam & condensate piping as needed.
  - Replace the two 120-gallon electric water heaters in year 5.
  - Replace the basement sump pump in year 1.

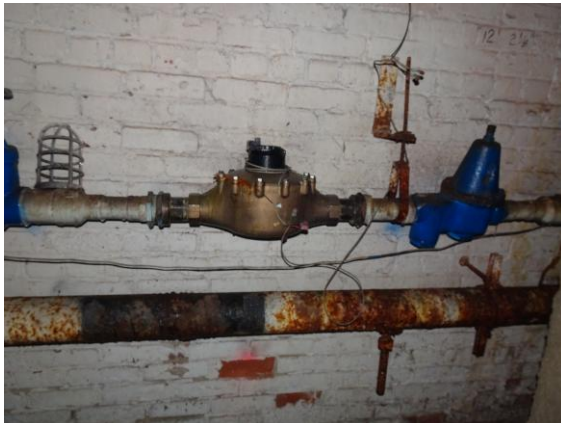
Domestic water main and meter.

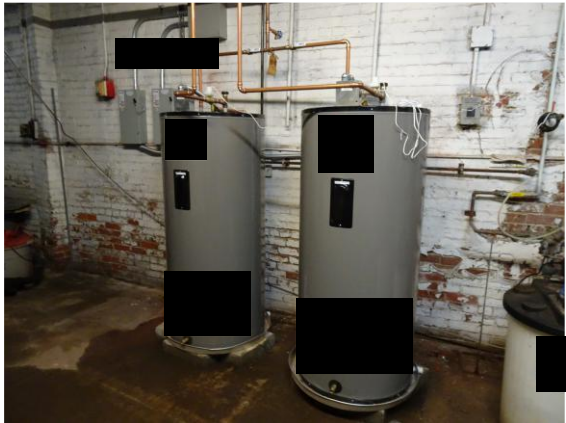
Domestic water heaters,

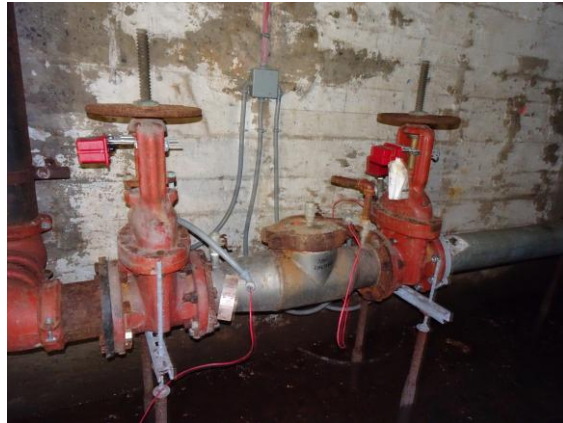
Fire protection main and backflow device.

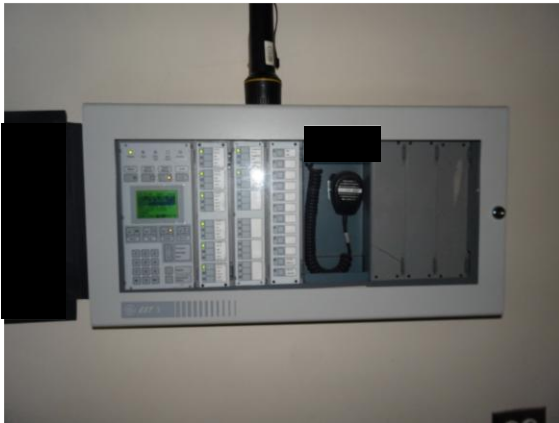
Fire alarm remote annunciator.

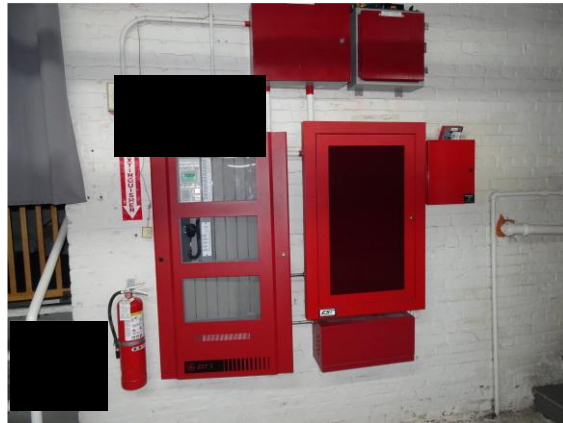
Main fire alarm panel.
