# CAPITAL NEEDS ASSESSMENT REPORT

██████████ High School  
██████████  
██████████ MA ██████████

Re: ██████████ High School, ██████████ MA  
Capital Needs Assessment  
Rimkus Consulting Group, Inc. Project # ██████████

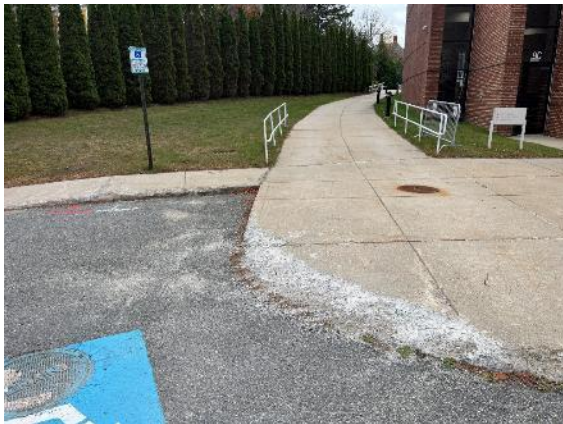
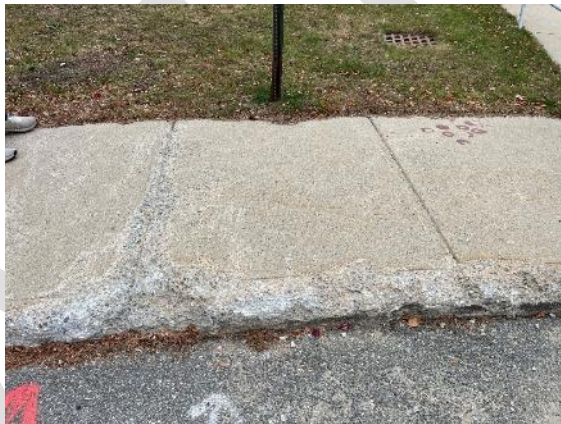
Damage to concrete sidewalk and curbing from snow removal and freeze/thaw cycling.

- Scrape and paint exterior handrails around perimeter of building, including patios and entryways in Year 3 and Year 8.
- Perform annual concrete repairs at sidewalks and curbing throughout property for damage caused during snow removal and freeze/thaw cycles (R&M).

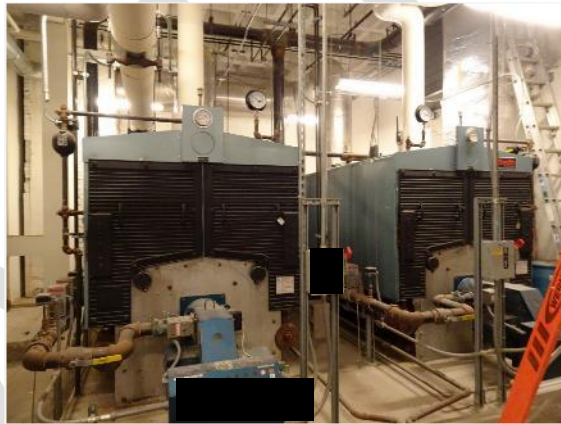
Heating boilers.

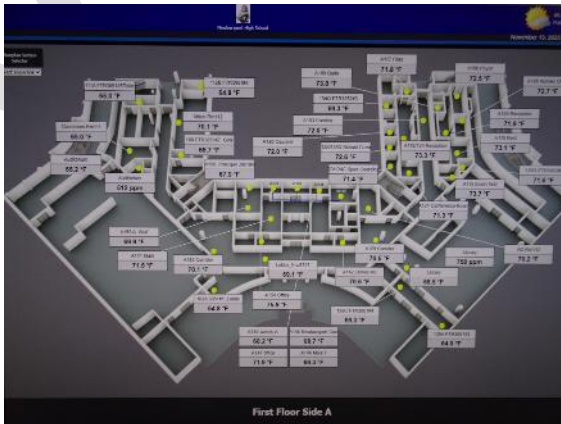
BMS system screen shots.

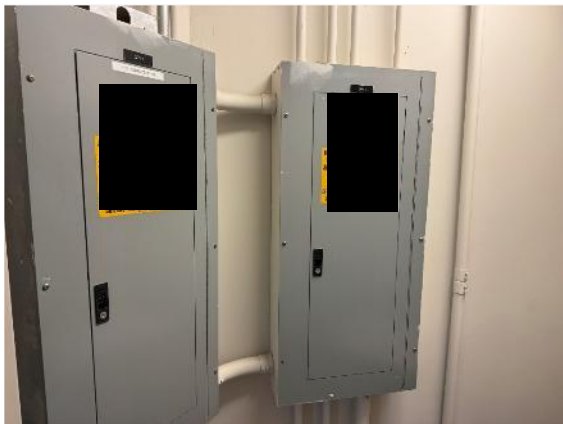
Typical electrical equipment.

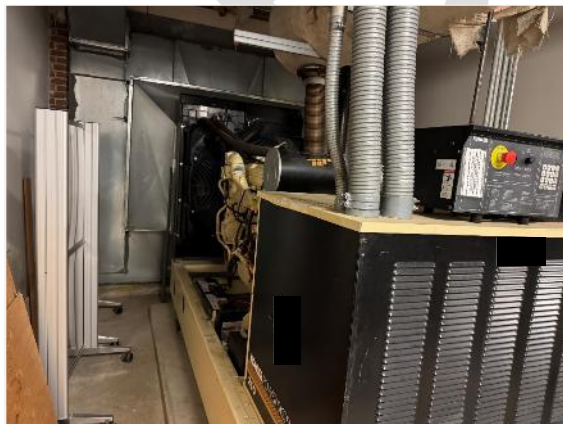
Emergency generator.

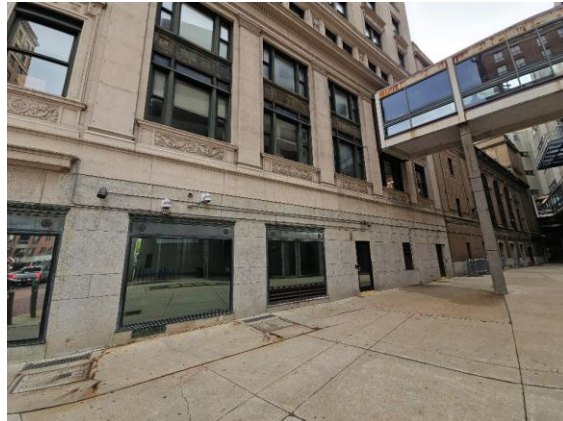
Side courtyard.

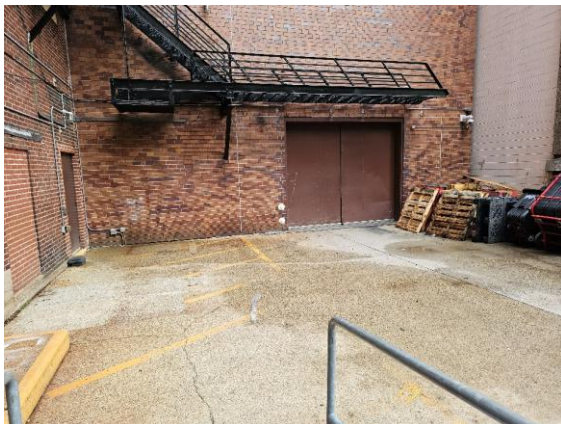
Loading dock platform and retaining wall.

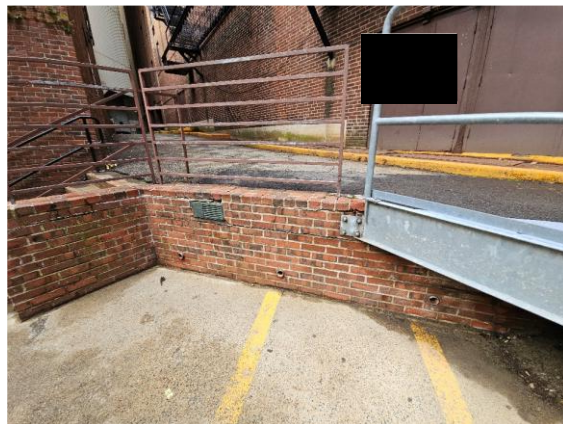
Asphalt driveway at loading dock.

| Item | Qty. | Unit | Unit Cost | Line Total-<br>Uninflated Capital | Line Total-<br>Inflated Capital | Immediate<br>Repairs | Year 1<br>2026 | Year 2<br>2027 | Year 3<br>2028 | Year 4<br>2029 | Year 5<br>2030 | Year 6<br>2031 | Year 7<br>2032 | Year 8<br>2033 | Year 9<br>2034 | Year 10<br>2035 |
|---|---|---|---|---|---|---|---|---|---|---|---|---|---|---|---|---|
| Implement asphalt crack repair and sealing program at existing asphalt. Assume 55,000 SF @ \$.35/SF every 5 years beginning in Year 1 (R&M). | 55,000 | SF | \$ 0.35 | \$ 38,500 | | | \$ 19,250 | | | | \$ 19,250 | | | | | |

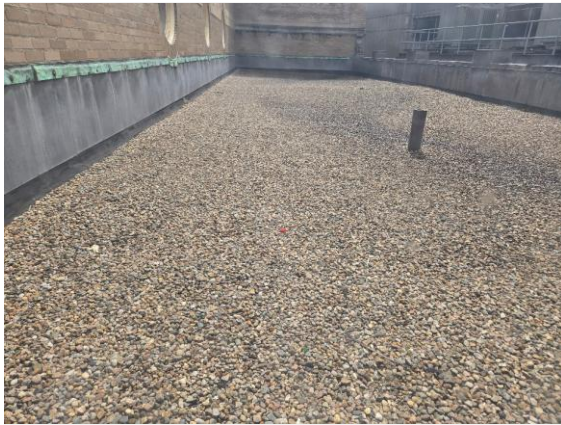
Ballasted roofs.

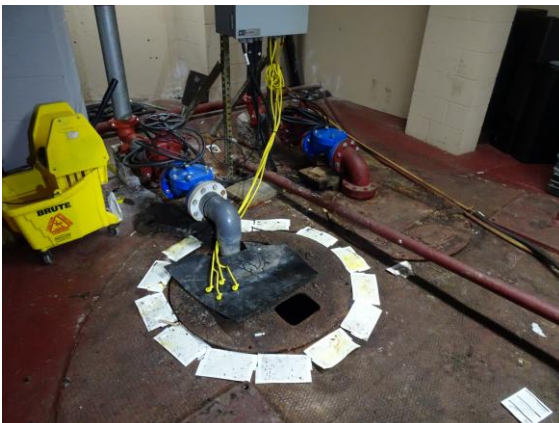
Sanitary ejector system.

- Replace the motors and VFD on the supply and return fans in year 2.
- Replace the roof mounted AHU #4 in year 1.
- Install split system units to replace the water source heat pumps and 20-ton cooling tower. Quote expected from Boch cost TBD.
- Perform a retrofit on the thermal storage tank manifold and controls in year 1.
- Service and possibly replace the leaking and valved off thermal storage tank in year 1.
- Replace the domestic hot water boiler in year 3.
- Replace four split system units (condenser and fan coil unit) totaling 11-tons in year 1.
- Budget amount to account for annual replacement/repair of domestic, sanitary, steam & condensate piping as needed.
- Close all openings above the ceiling in the wall at the thermal storage room to prevent cold air infiltrating nearby spaces.
- Ongoing repairs and maintenance to the sewage ejector pump system. Cost TBD.

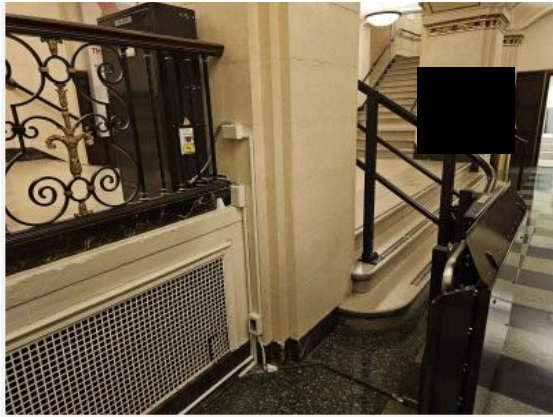
Incline stair lift

- Replace Vertical Incline Lift in the next 2-5 years
- Modernize the freight elevator in the next 5-7 years.
